**SITE ASSESSMENT REPORT
FOR THE
SMEAD AVENUE DRUM SITE
TOLEDO, LUCAS COUNTY, OHIO**

Date Prepared:	August 1, 2012
TDD No.:	S05-0001-1205-008
Document Control No.:	1851-2A-AWFL
Contract No.:	EP-S5-06-04
START Project Manager:	TJ McFarland
Telephone No.:	(440) 202-2802
U.S. EPA On-Scene Coordinator:	Jon Gulch

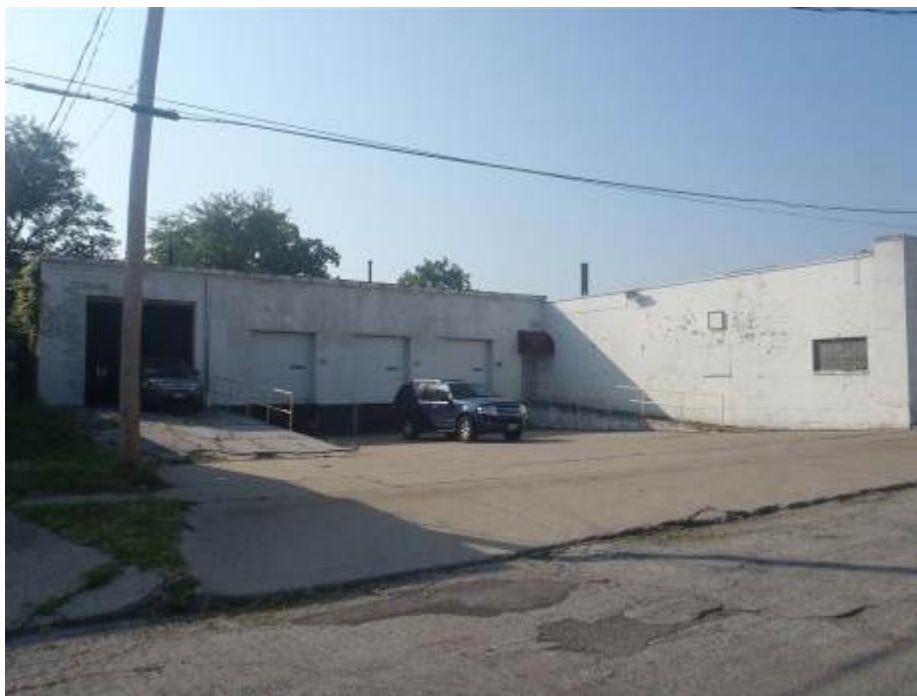
Photograph No.: 1

Subject: Loading docks to Site building at north end of the Site

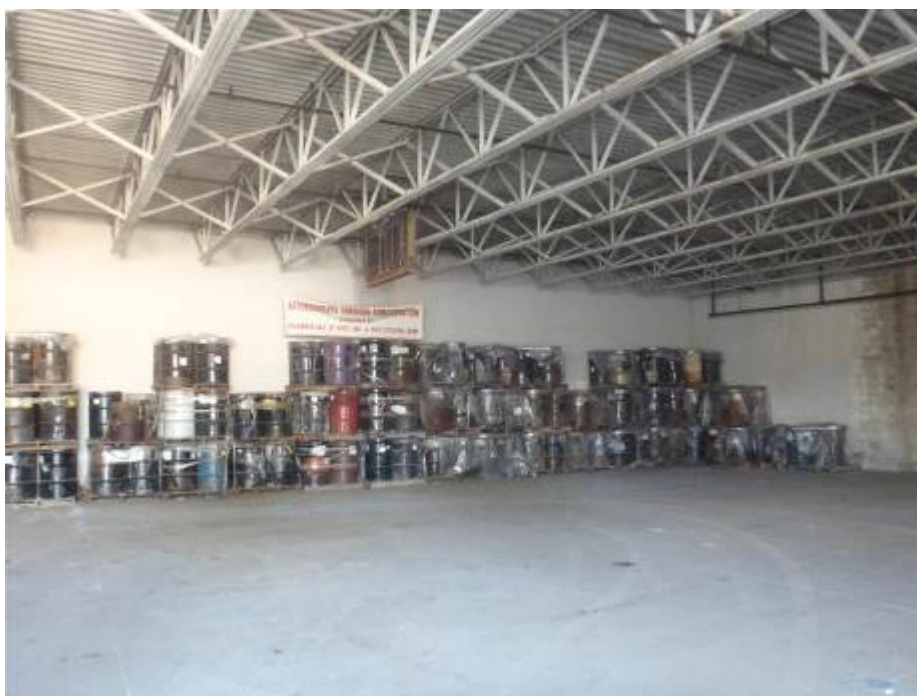
Photograph No.: 2

Subject: Area A containing numerous stacked drums along southeast wall

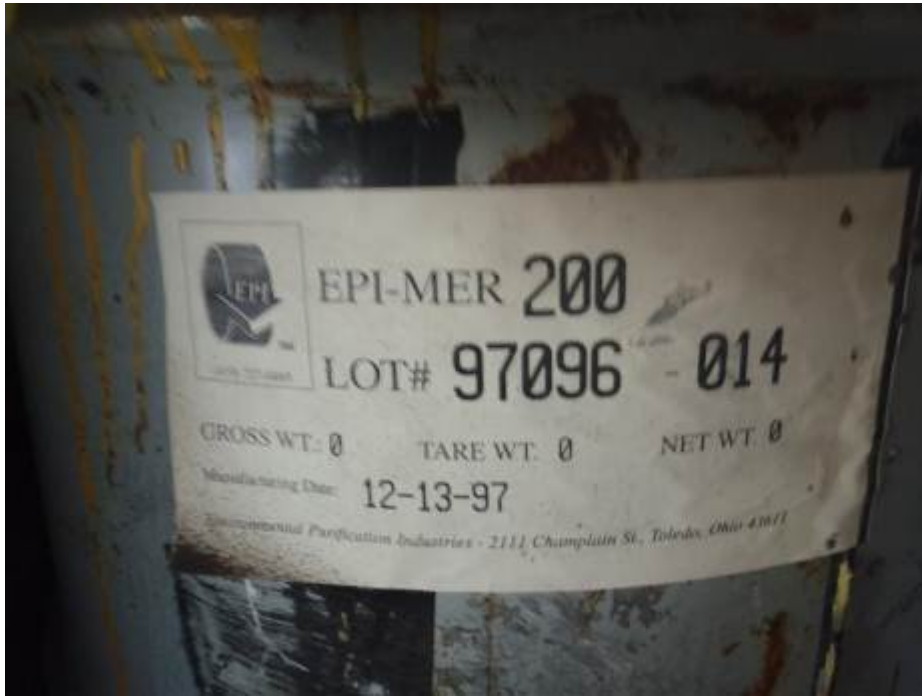
Photograph No.: 3

Subject: EPI label on drum in Area A

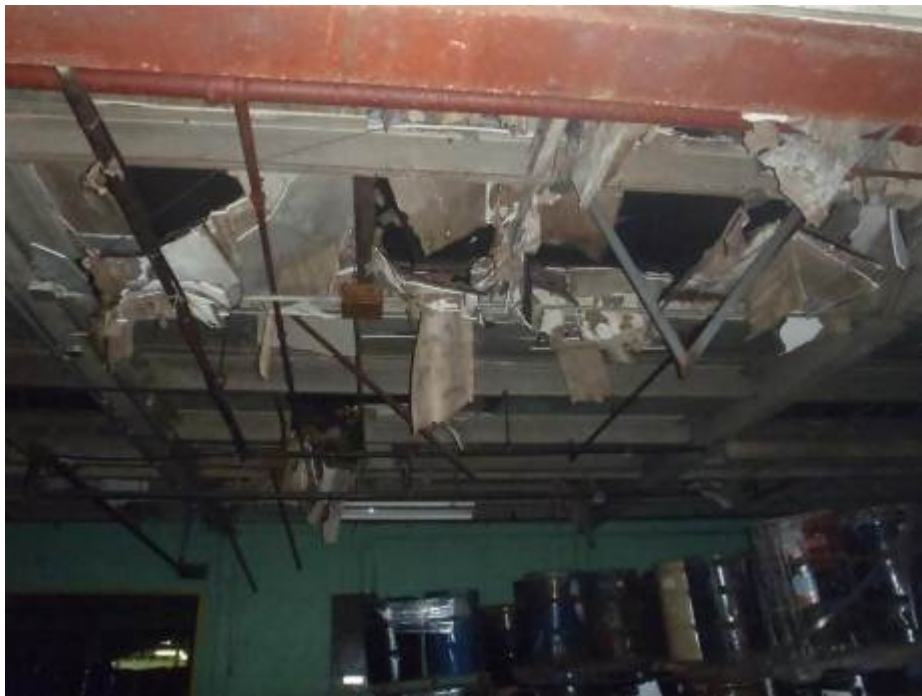
Photograph No.: 4

During the site assessment, several areas inside the Site building contained several inches of standing water from deteriorating roofs. Some drums containing unidentified wastes were located in flooded areas of the building. Infiltration of rain water and snow melt increases the likelihood of a release of potentially hazardous substances from the drums.

Subject: Partially collapsed ceiling over stacked drums in Area B

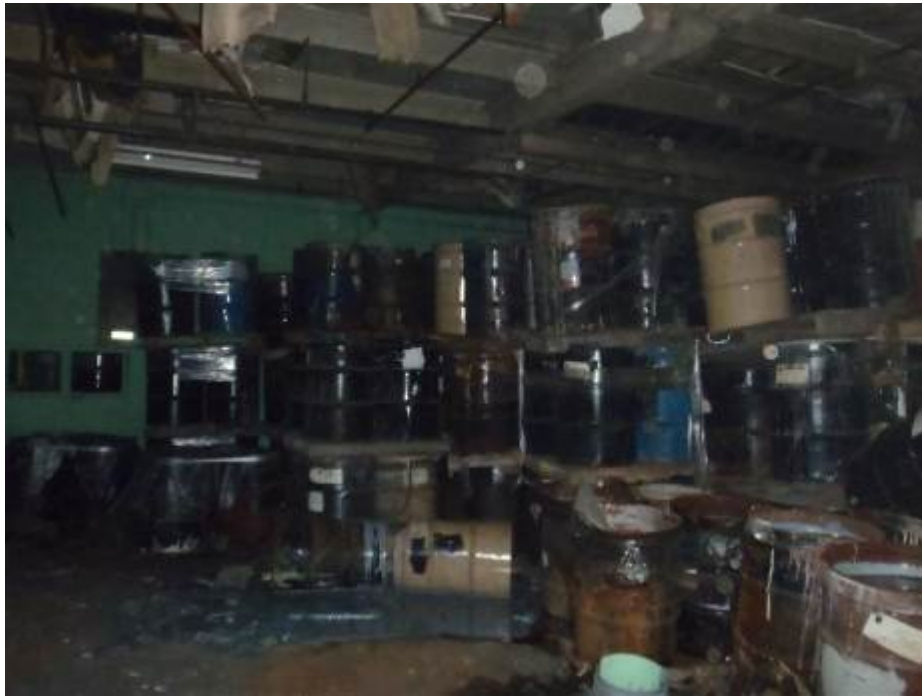
Photograph No.: 5

Subject: Haphazardly stacked drums in Area B

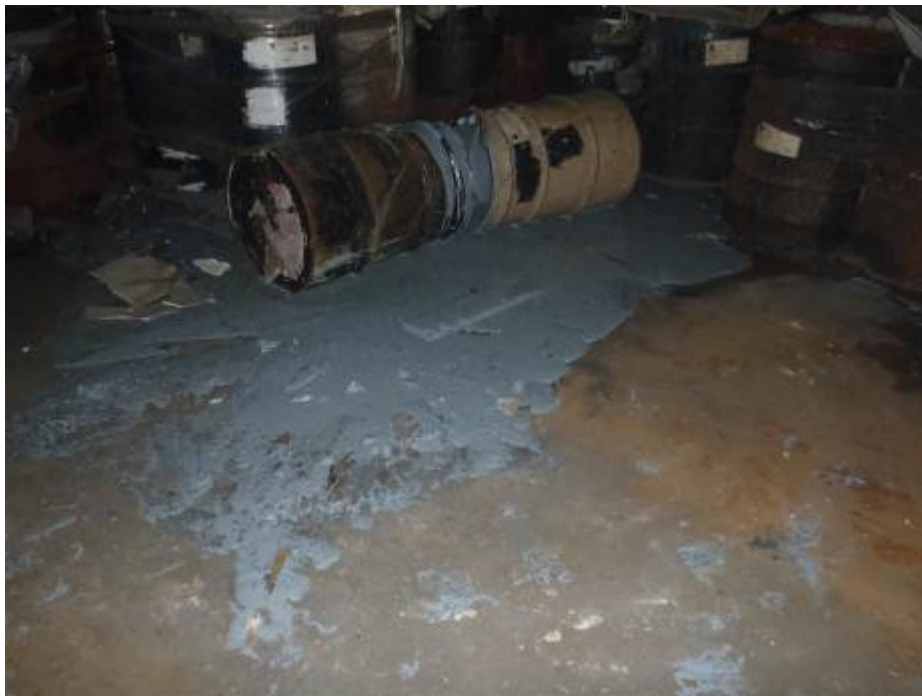
Photograph No.: 6

Subject: Fallen drums with contents spilled onto floor in Area B

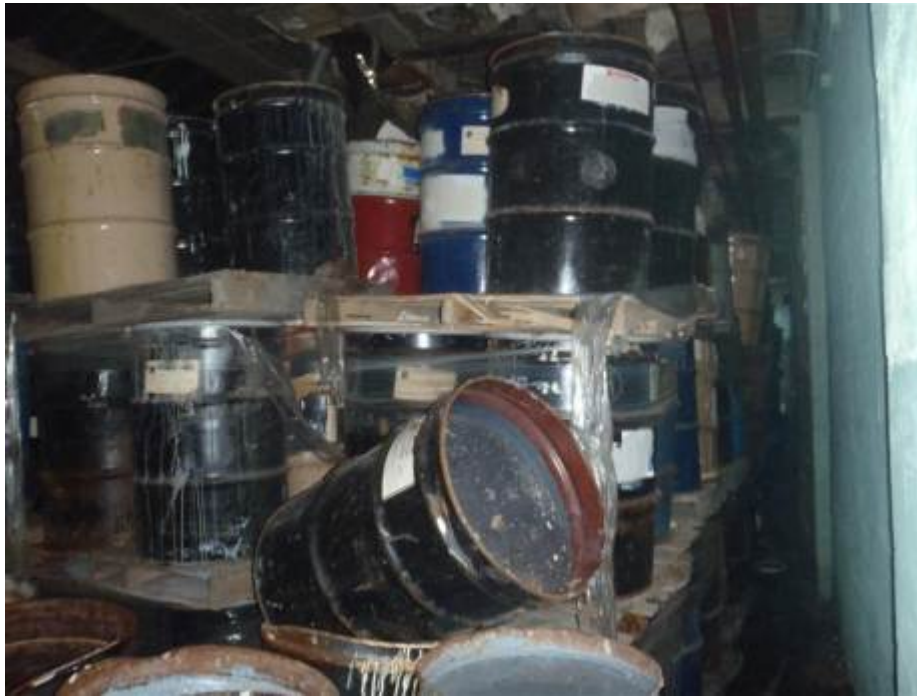
Photograph No.: 7

Subject: Haphazardly stacked drums in Area B

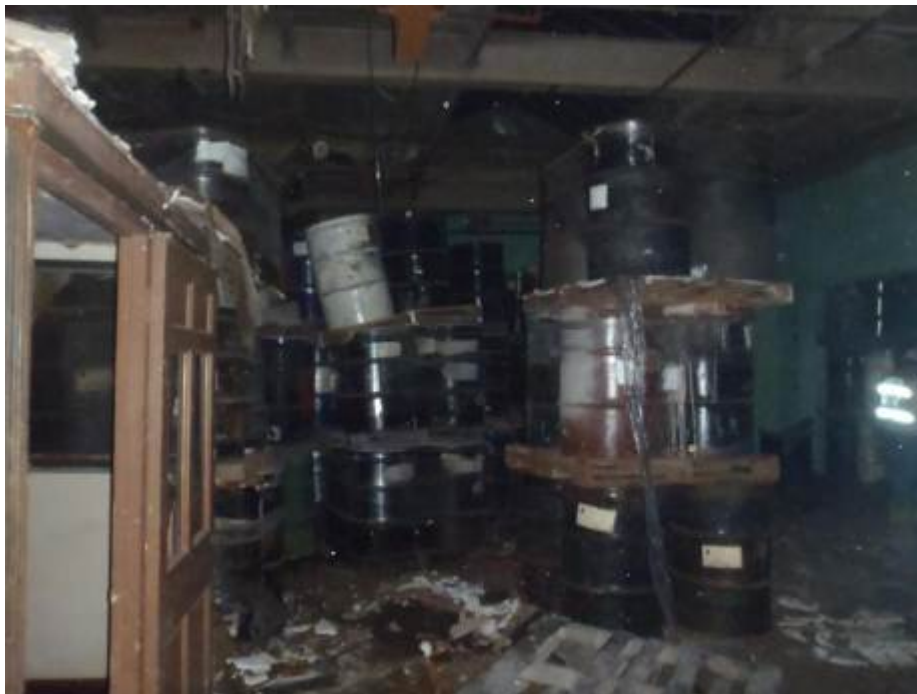
Photograph No.: 8

Subject: Area C showing numerous stacked drums

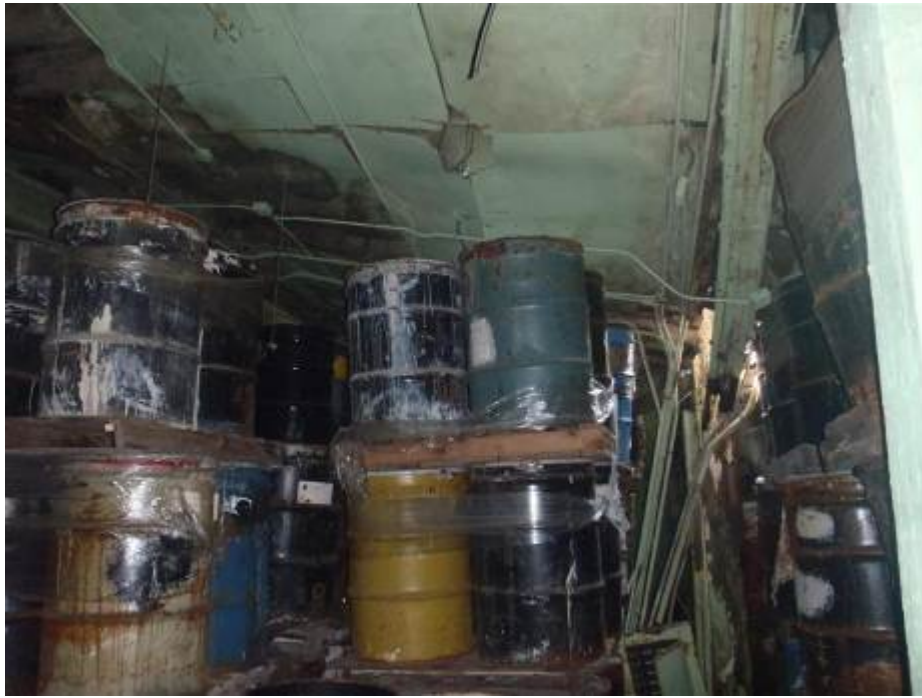
Photograph No.: 9

Subject: Partially collapsed roof over stacked drums in Area C; drums are supporting the weight of the roof
